BUREAU OF SHIPS GROUP TECHNICAL INSPECTION REPORT

U.S.S. ARDC 13

⑥ OPERATION CROSSROADS. Defense Atomic Support Agency
Washington, D. C. 20301

DETAILED DESCRIPTION OF HULL DAMAGE

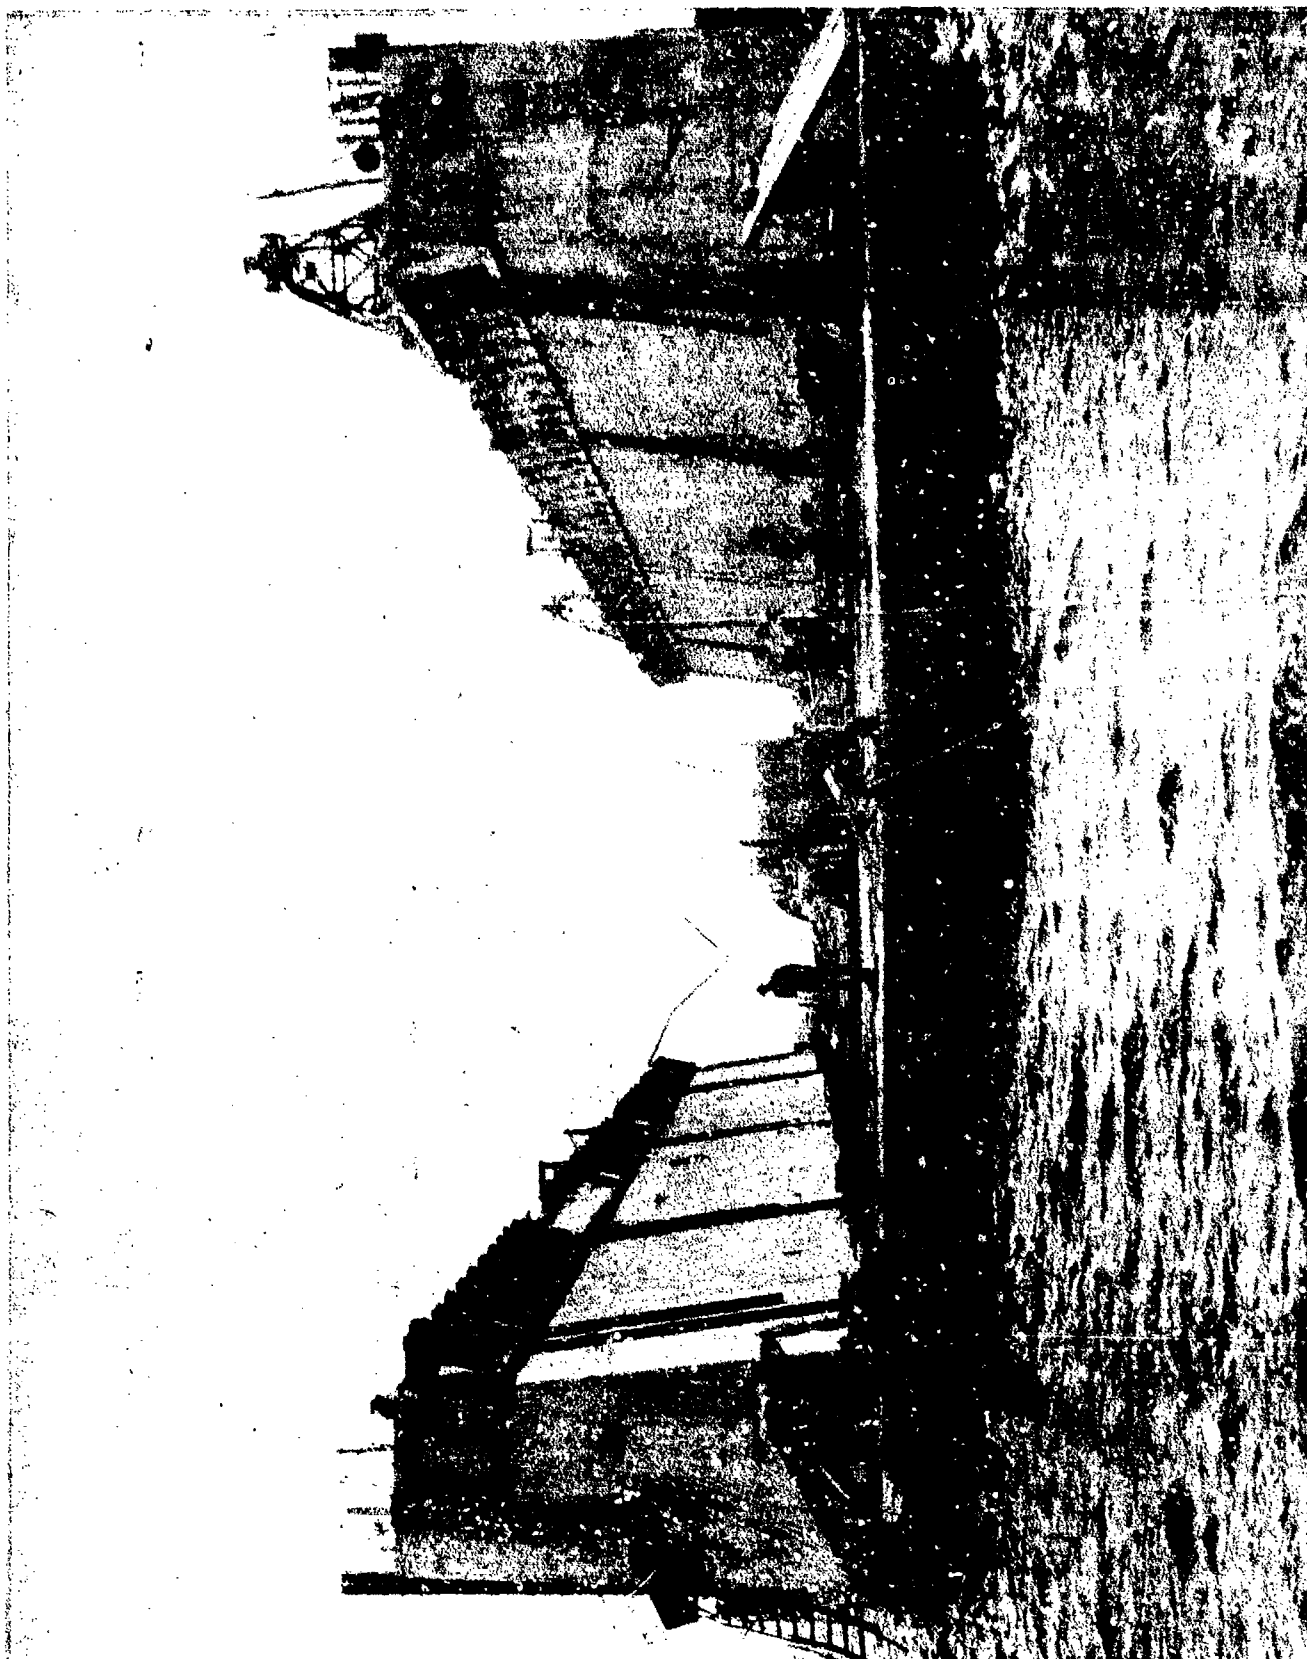
AA-CR-227-50-132. View from dead ahead after Test A.

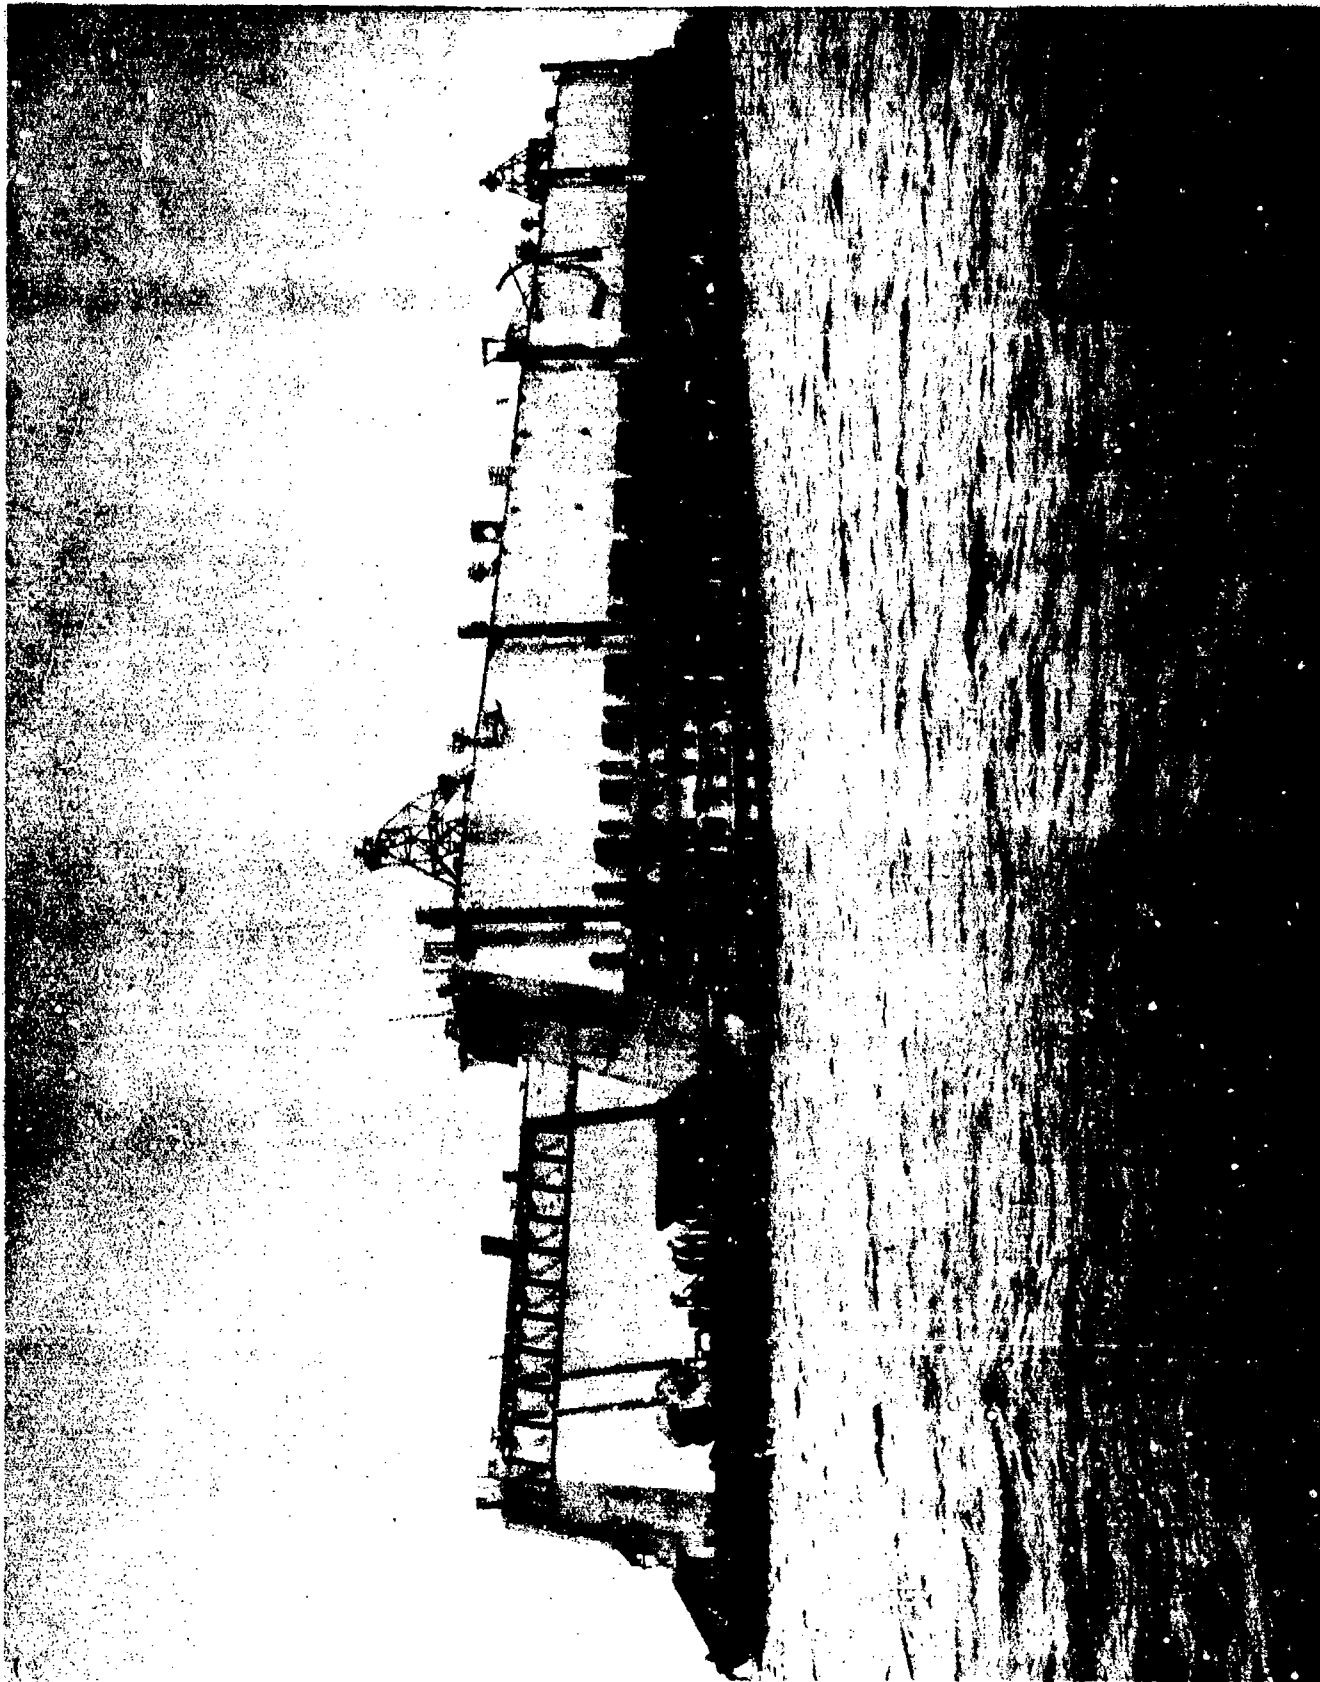
AA-CR-227-50-133. View from off port bow after Test A.

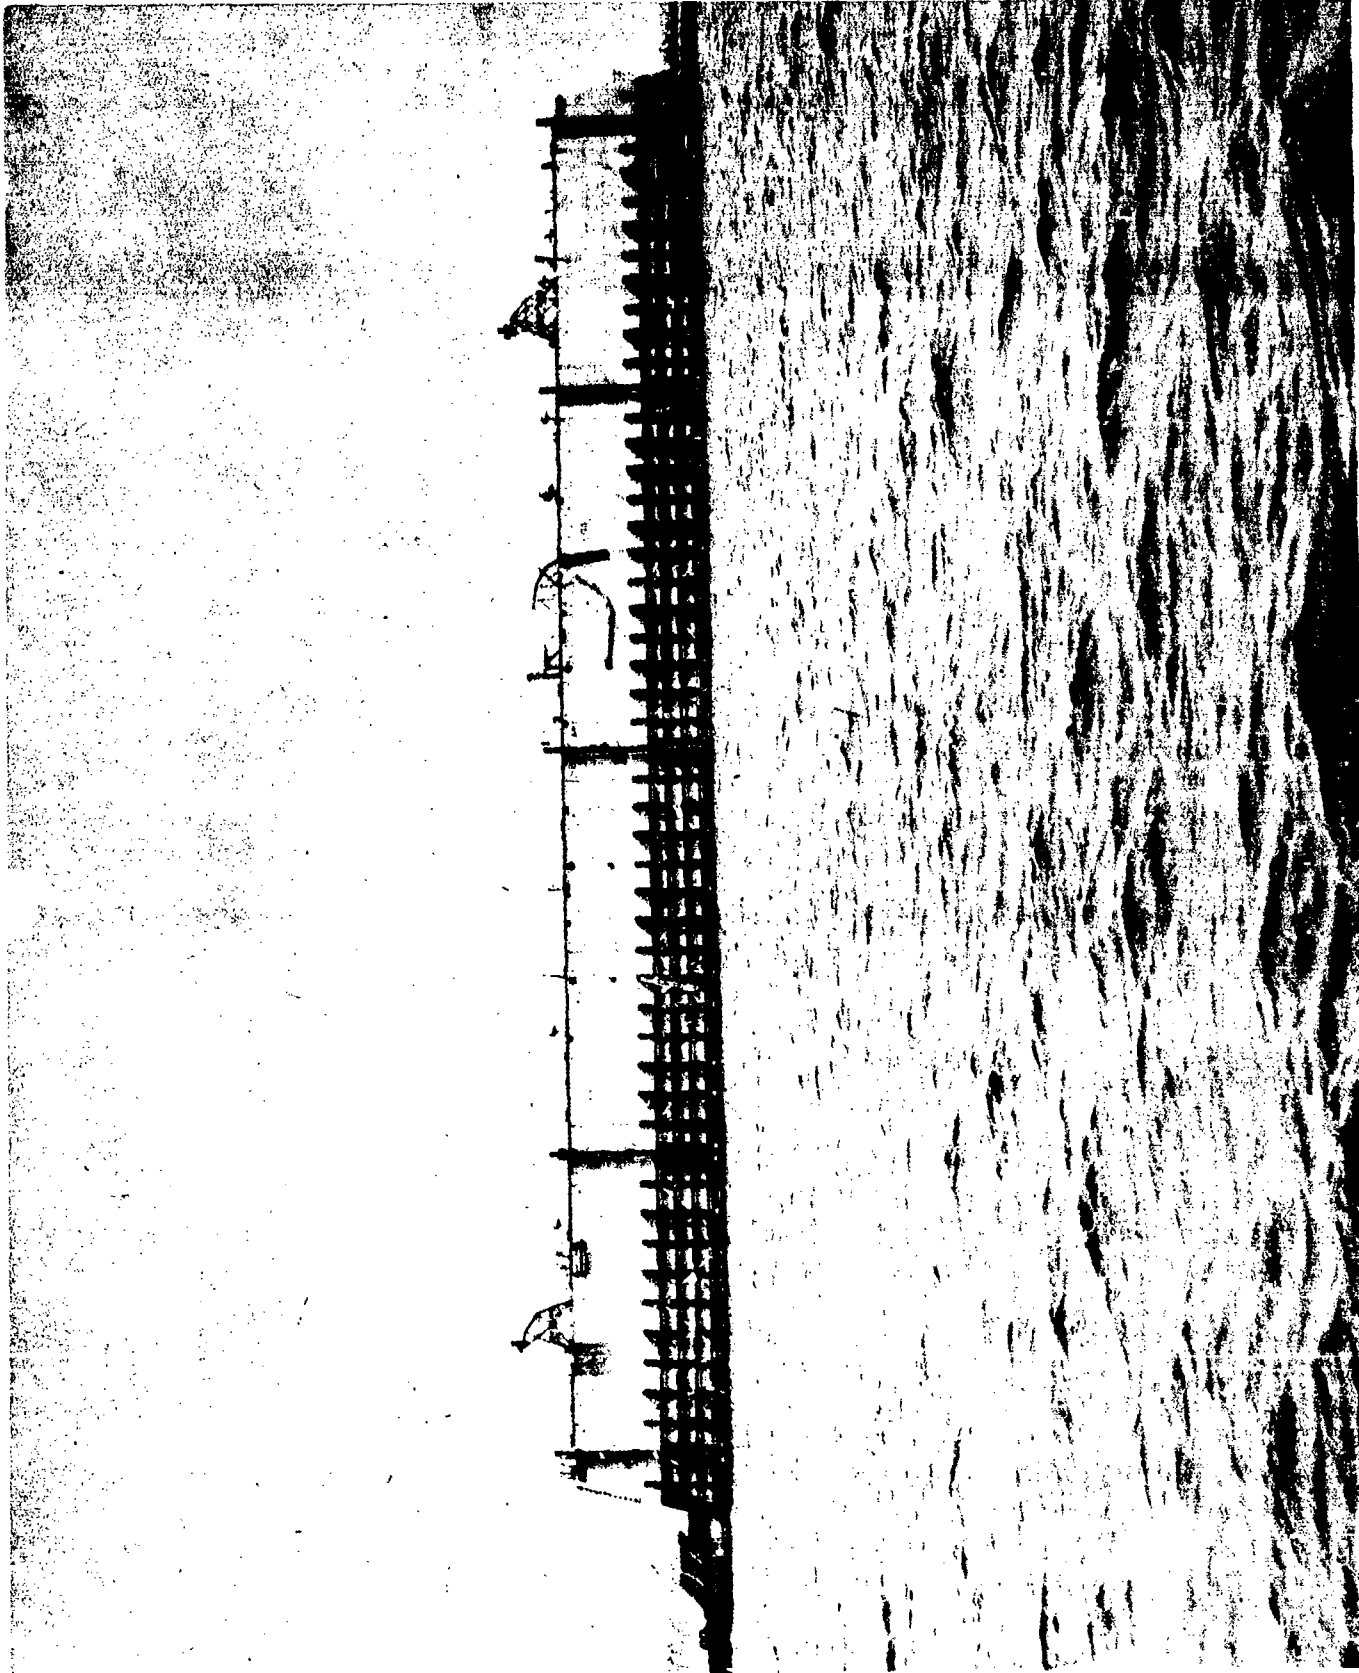
AA-CR-227-50-134. View from off port beam after Test A.

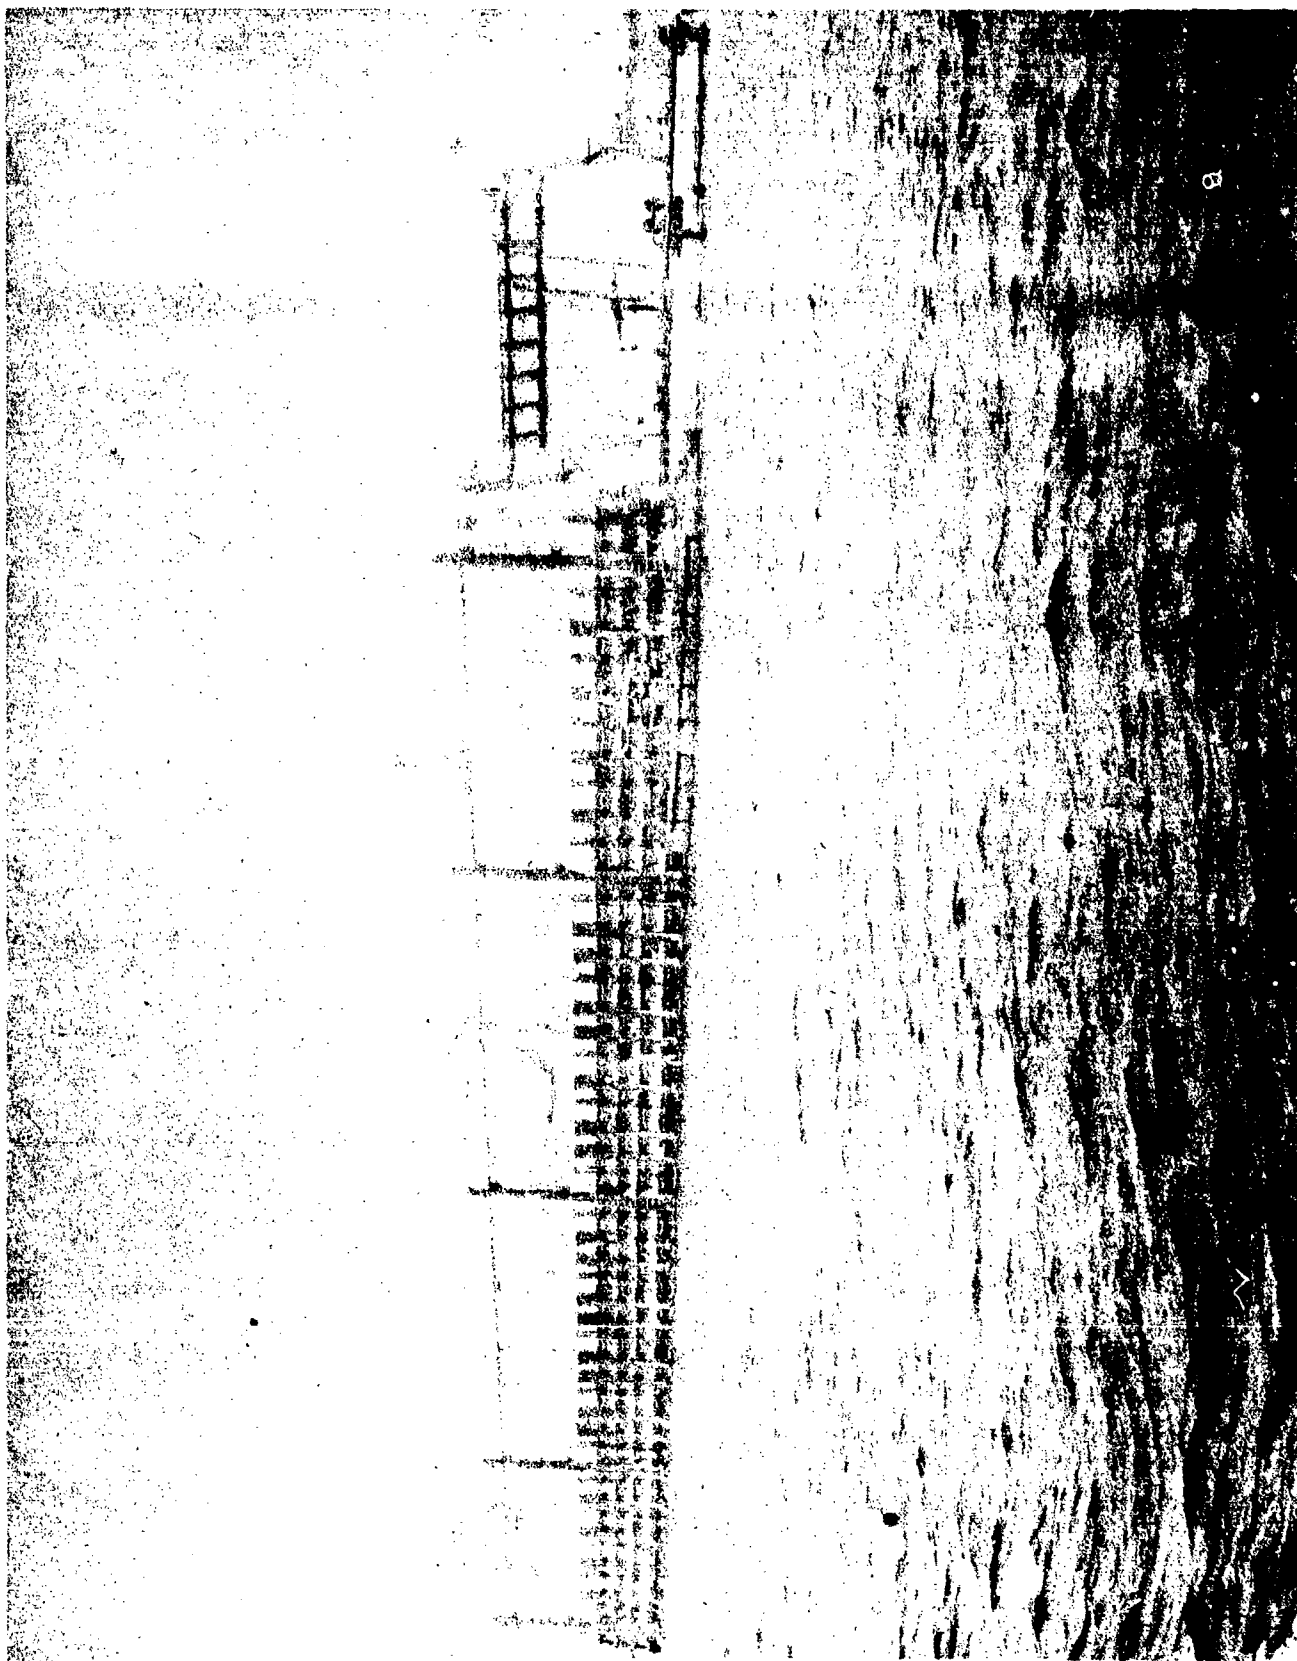
AA-CR-227-50-135. View from off port quarter after Test A.

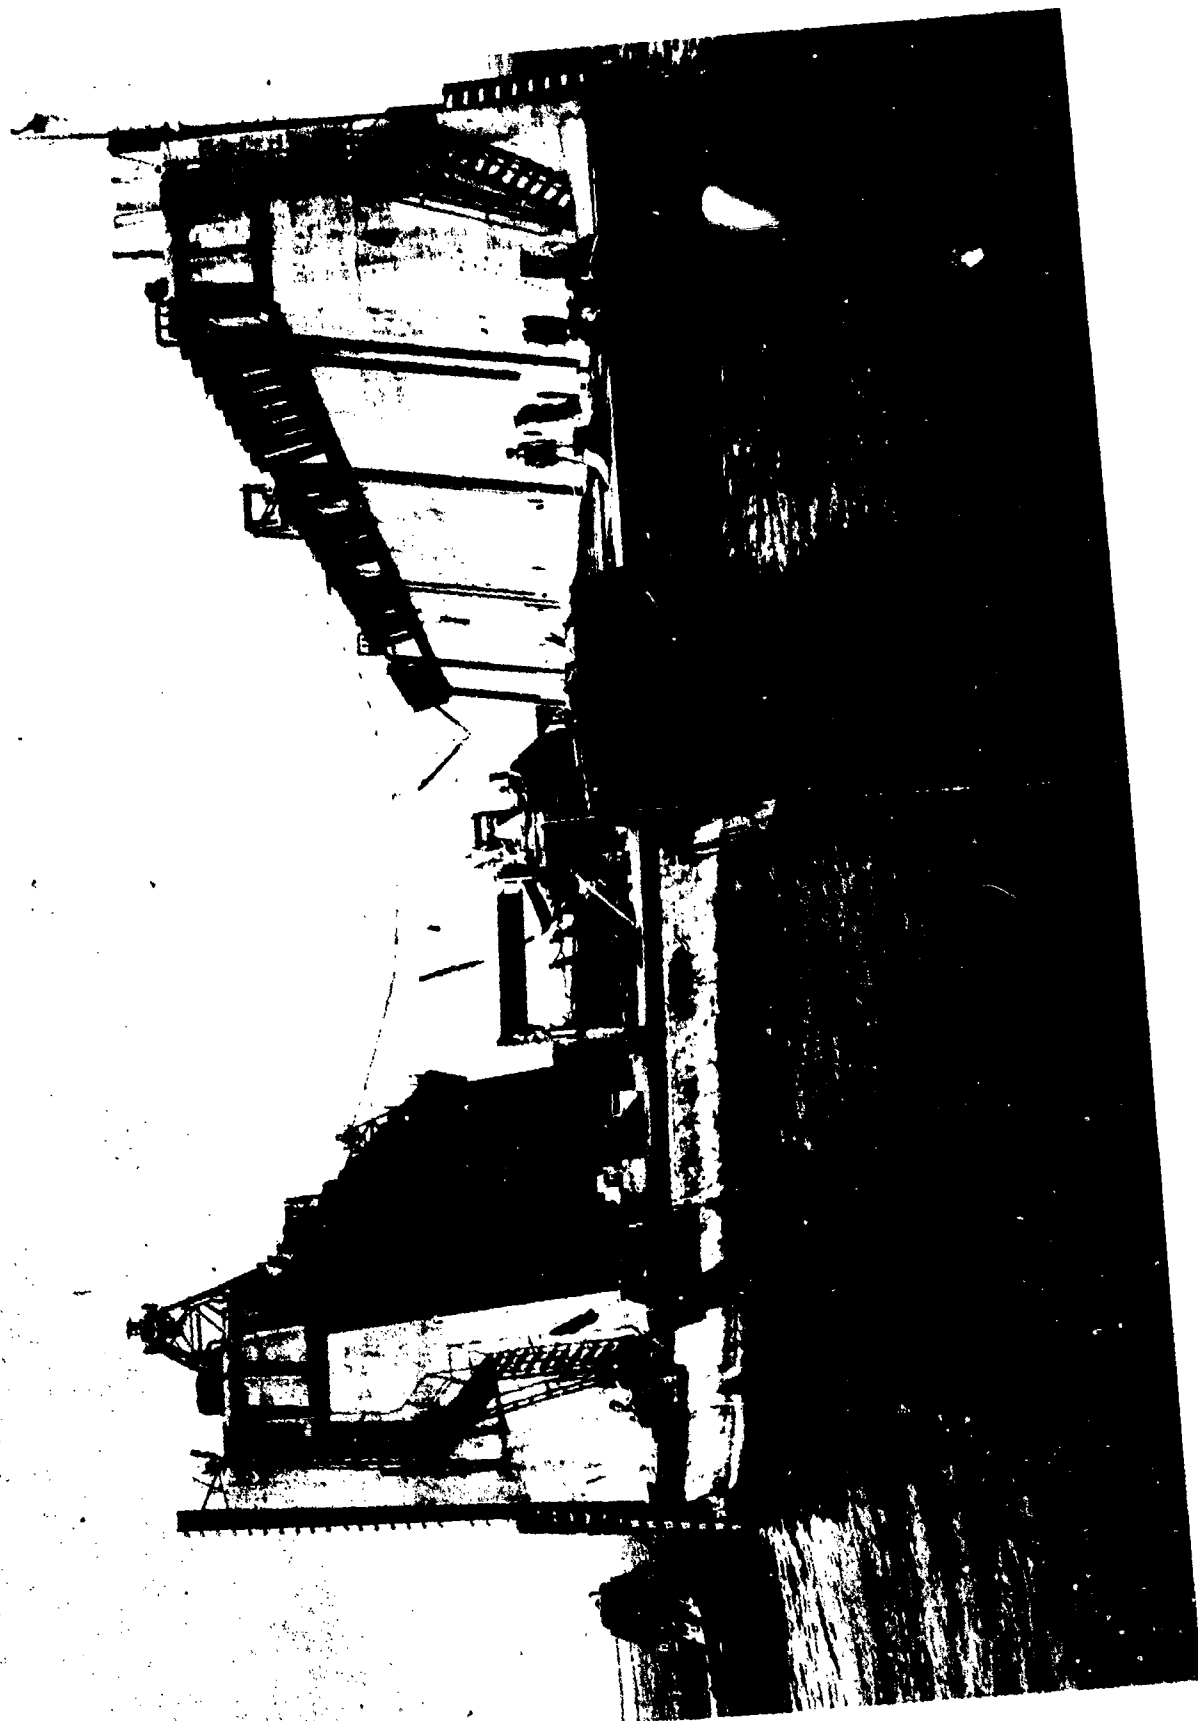
AA-CR-227-50-128. View from astern after Test A.

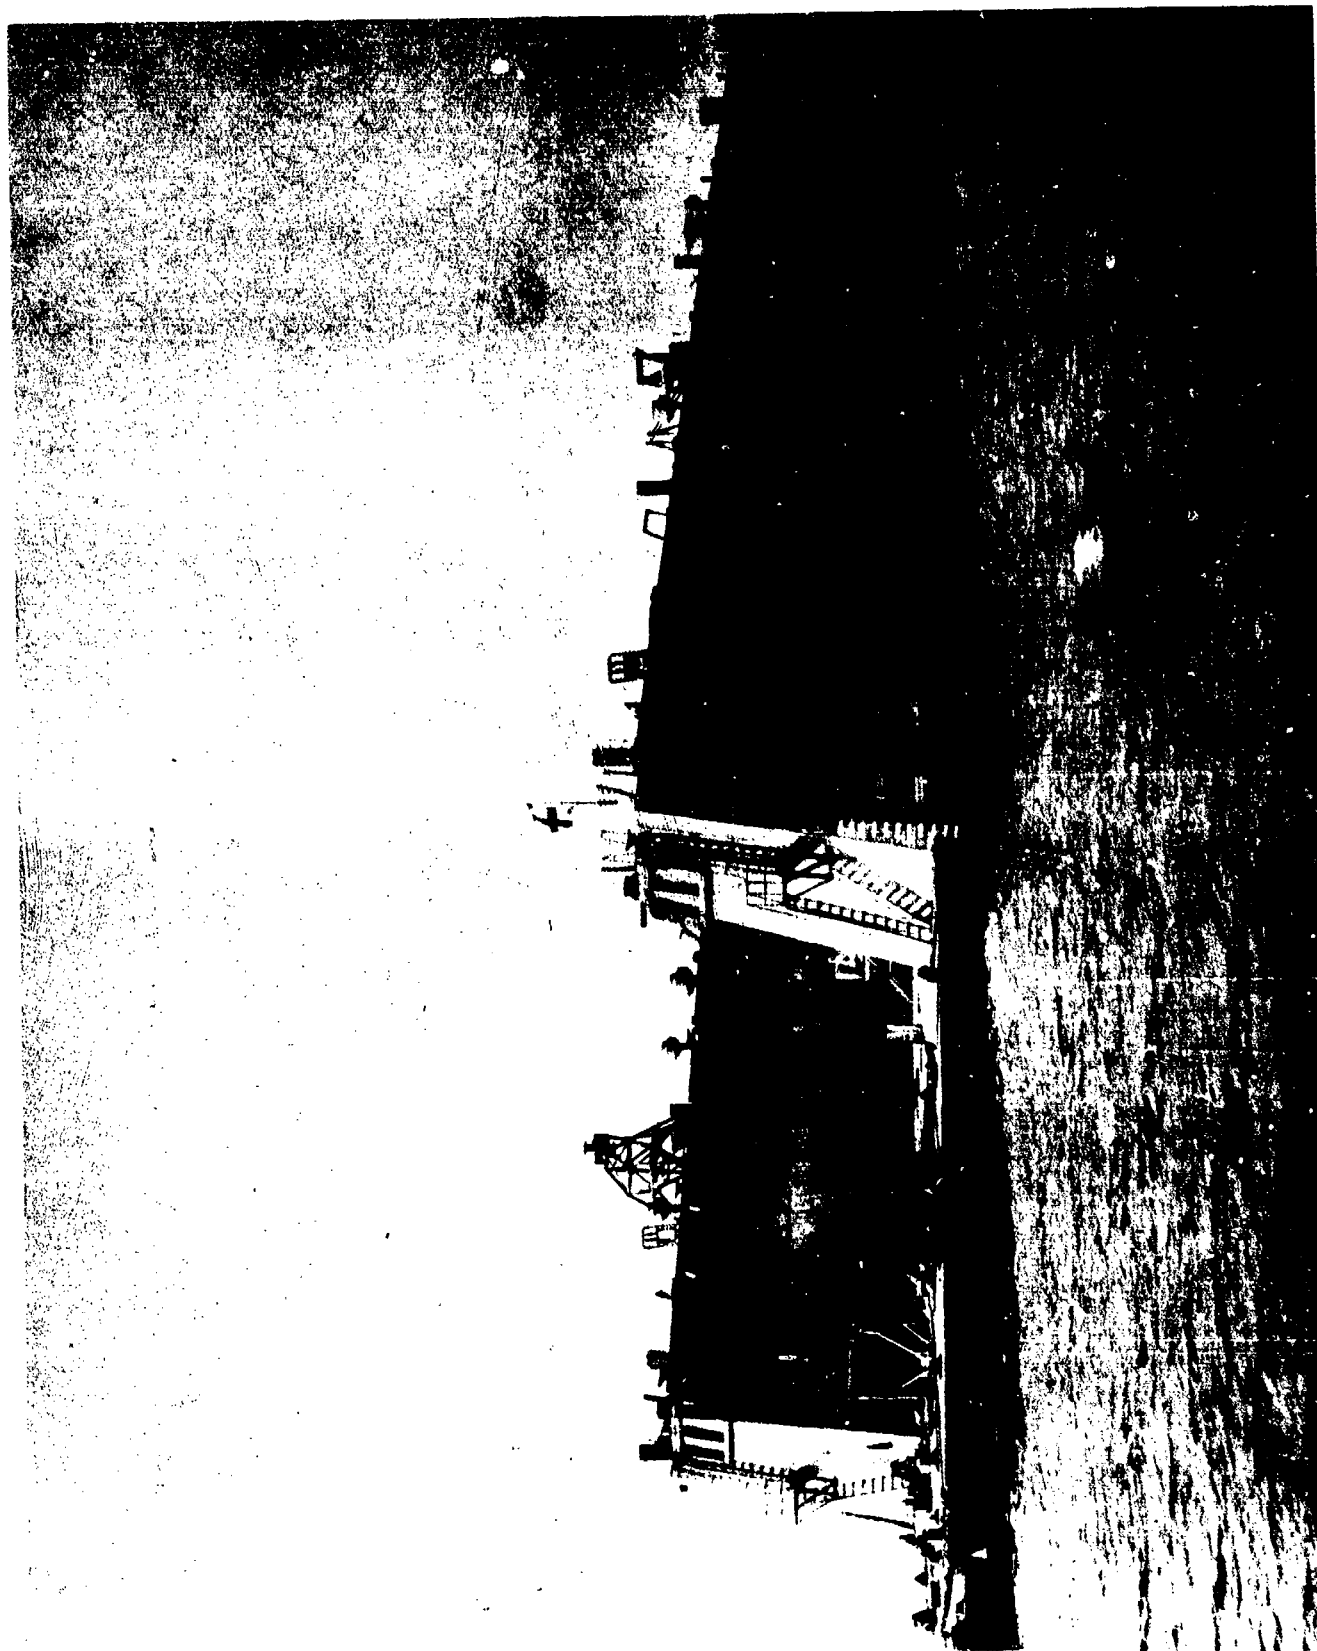
AA-CR-227-50-129. View from off starboard quarter after Test A.

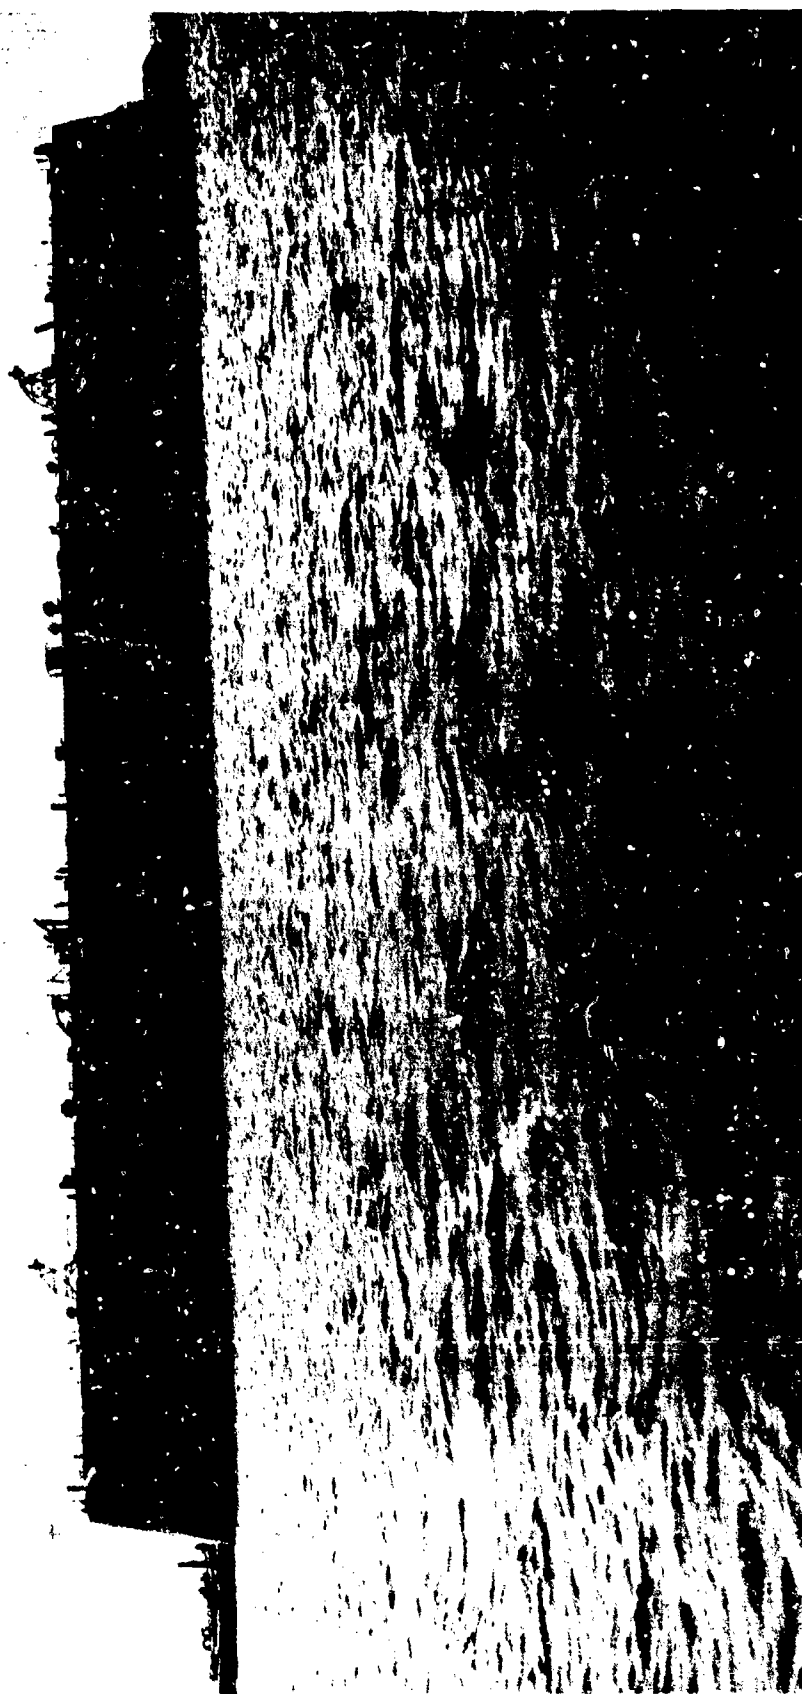
AA-CR-227-50-130. View from off starboard beam after Test A.

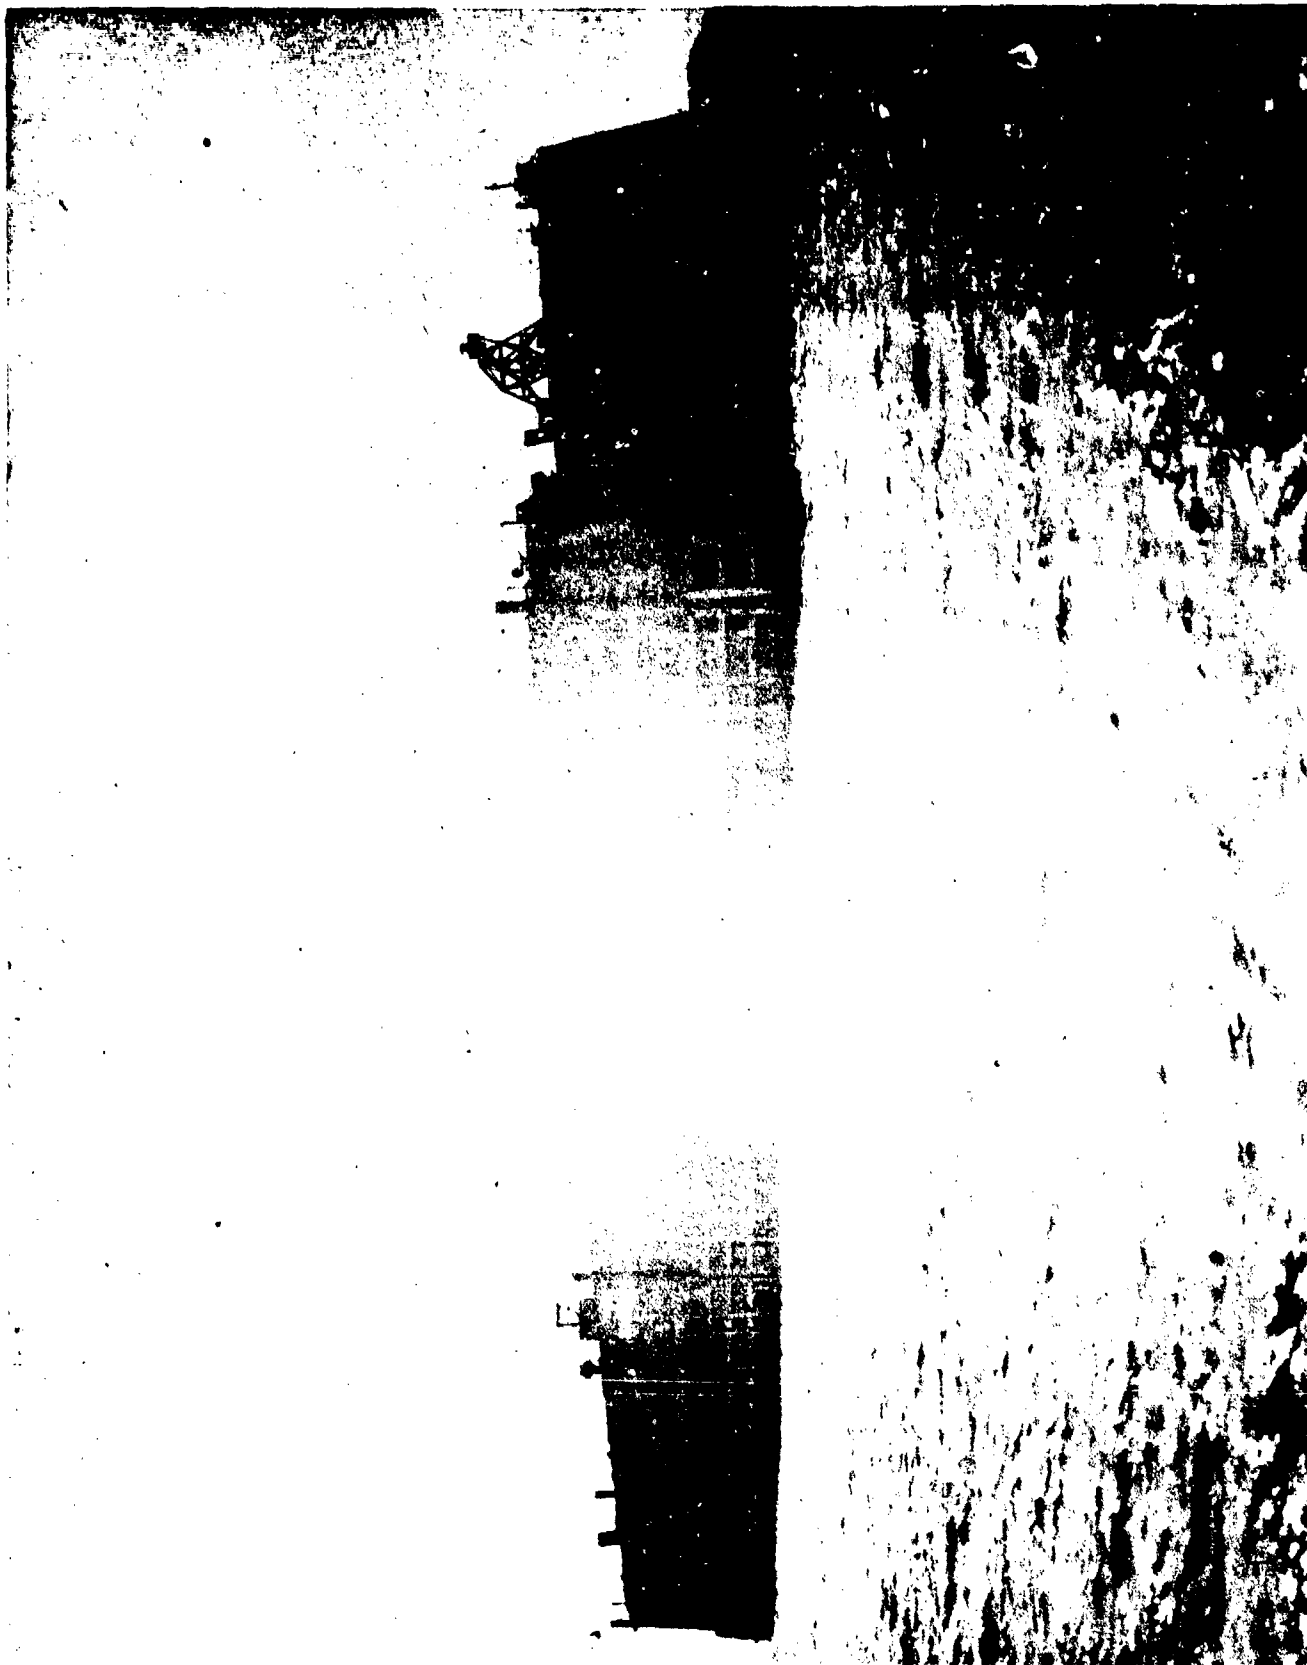
AA-CR-227-50-131. View from off starboard bow after Test A.

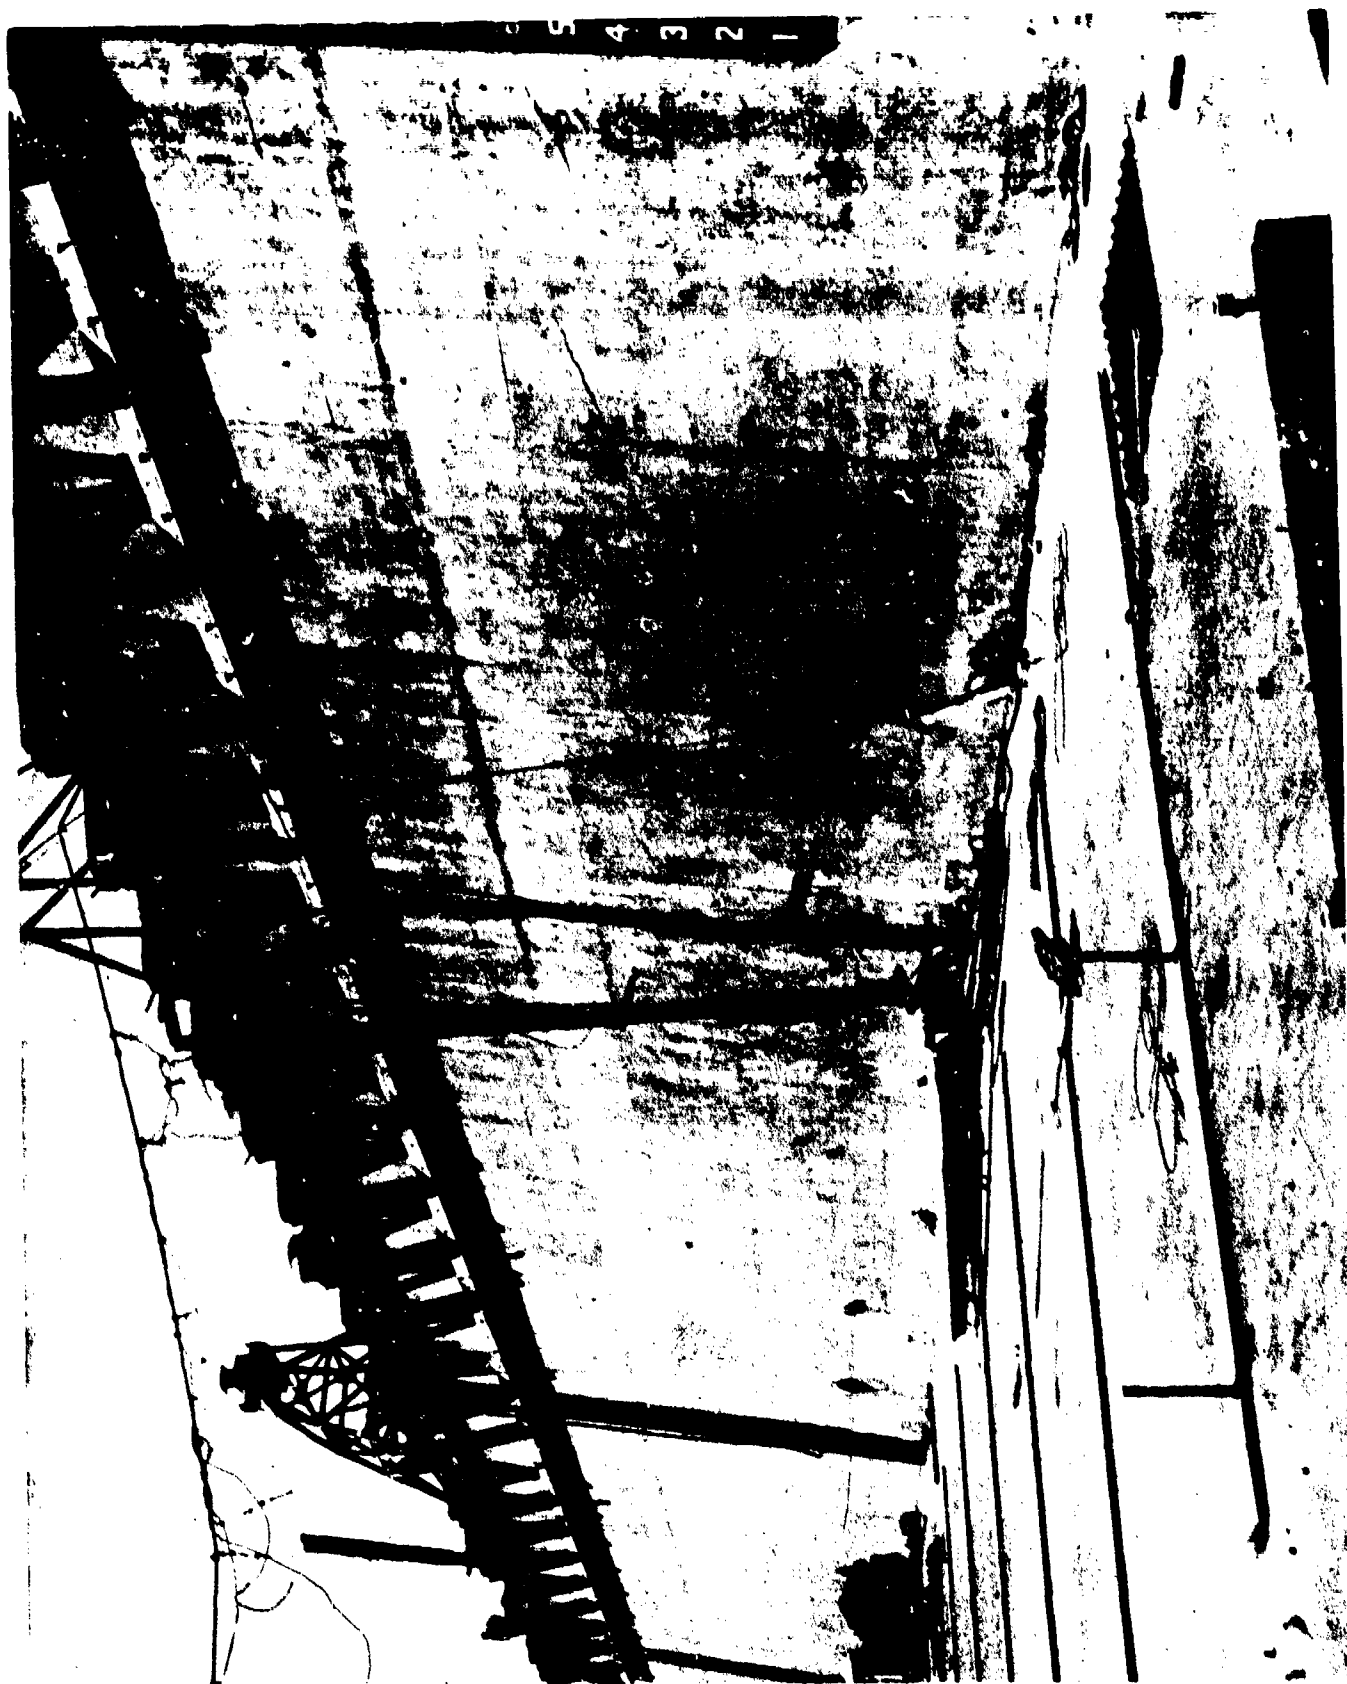
The inboard face of the port wall amidships contains longitudinal cracks running four to five feet from the top of the wall, and at about midheight (Photo 1914-11, page 62). There is a continuous set of cracks running about five feet above the floor on the starboard wall (Photos 1916-2, 1963-5, pages 61 , and 65).

AA-CR-82-1914-11. View looking aft along port wing wall showing longitudinal cracks at about mid-height of wall.

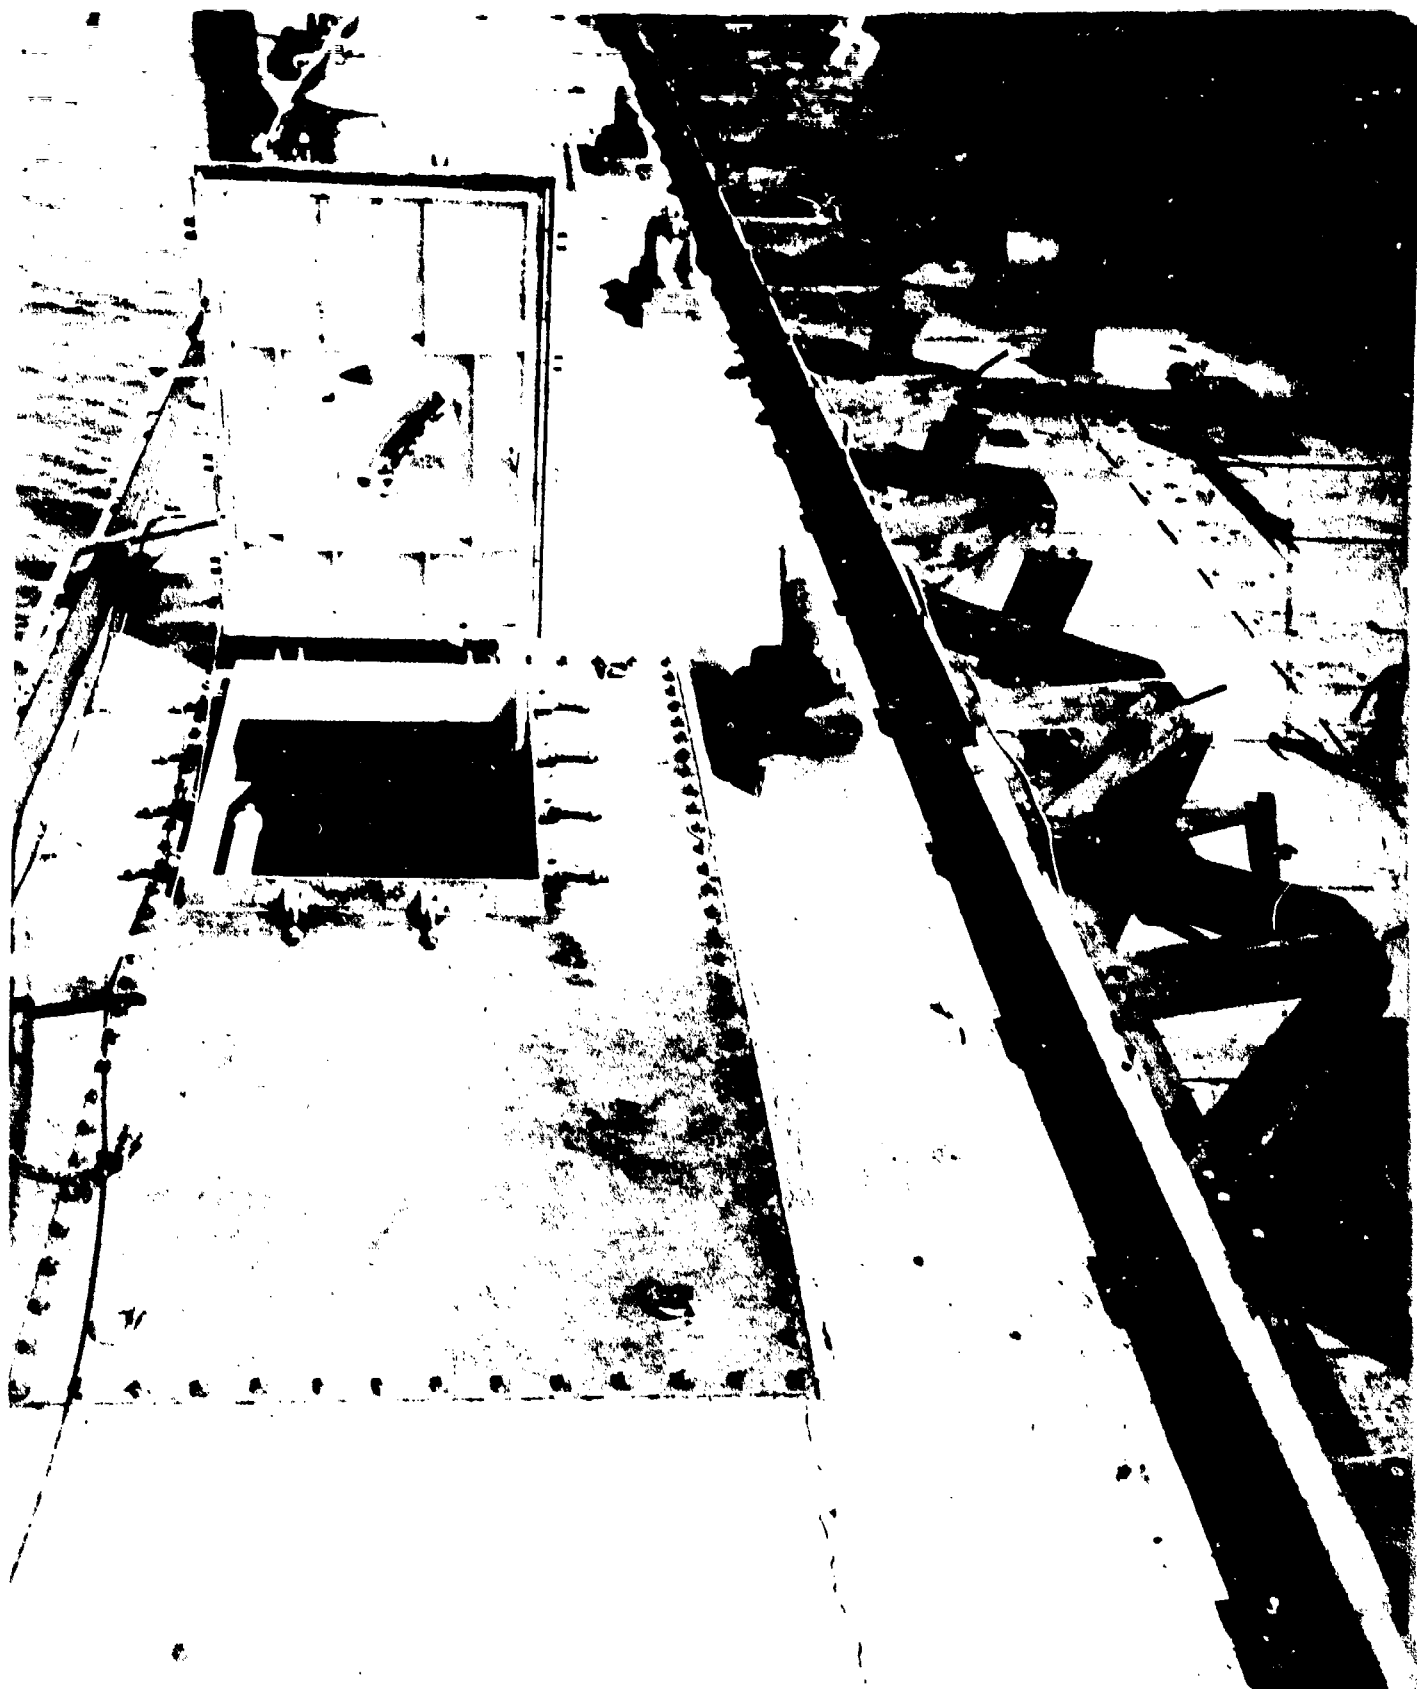
AA-CR-82-1914-4. View looking forward, port side, showing crack in "A" deck.
